Grant-Kohrs Residence

Introduction

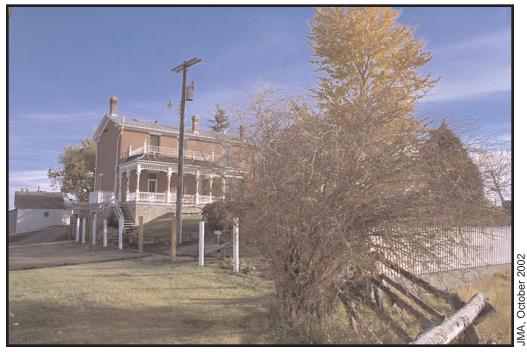
The transition between poor and well drained soils on the Ranch is clearly evident on the ground. Referred to as the "bench," this demarcation in soil type and quality is defined both by changes in elevation and land use (see Photo 3-3-1). The historic ranch home built by Grant in 1862, as well as many of the oldest outbuildings (such as the bunkhouses, ice house, poultry houses, and livestock barns and stables), are located on this upland terrace consisting of very deep and well drained Beaverell loams.

Photo 3-3-1 : (COMP-01) The Grant-Kohrs residence is located along the "bench," a demarcation in soil type and quality that is defined both by changes in elevation and land use.

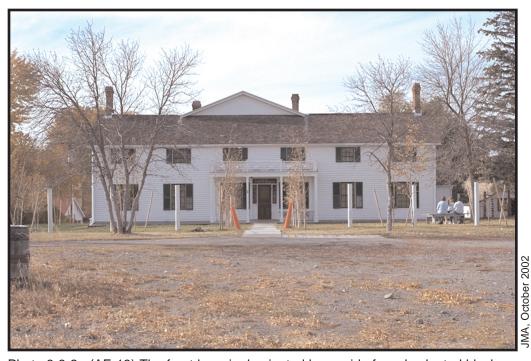
The front lawn is dominated by a grid of newly planted black cottonwoods (*Populus trichocarpa*), (see Photo 3-3-2). A single row of these trees edge the walkway and side yards; a double row edges the front. All these trees, planted during 2002, are located 15 feet apart and are intended to restore the historic conditions dating back to the 1870s.² Two other mature cottonwoods are located along the east side of the fence to the south. Three green ash trees

Photo 3-3-2: (AE-13) The front lawn is dominated by a grid of newly planted black cottonwoods.

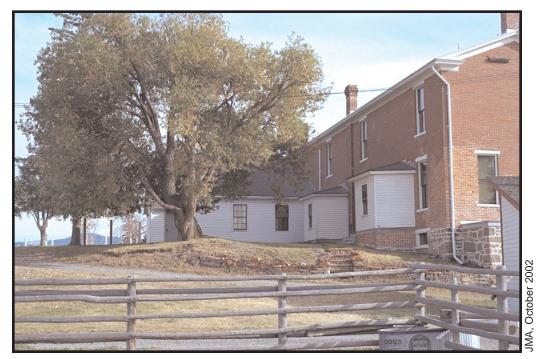
The north side of the house contains three trees, including a large black willow (*Salix scoulerana*) opposite the ice house, a juniper (*Juniperus occidentalis*) along the gravel access drive near the wooden walkway, and a blue spruce (*Picea pungens*) near the brick walk extending from the front porch (see Photo 3-3-3).

Photo 3-3-3: (AG-02) A large black willow occupies the north lawn of the house.

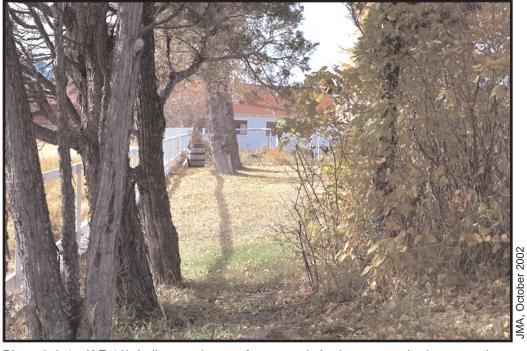
The remaining trees surrounding the Grant-Kohrs residence are found in the lower garden (see Photo 3-3-4). These include a cluster of trees containing one juniper and two boxelders (*Acer negundo*) along the front fence. Five junipers and a small cluster of lilac shrubs (*Syringa vulgaris*), and one twinberry honeysuckle (*Lonicera involverata*) are located along the south edge of the fence near the eastern corner. Two large lanceleaf cottonwoods (*Populus accuminata*) are located along the south edge of the fence, just to the east of the flower garden.

Photo 3-3-4: (AE-18) A diverse cluster of trees and shrubs occupy the lower garden.

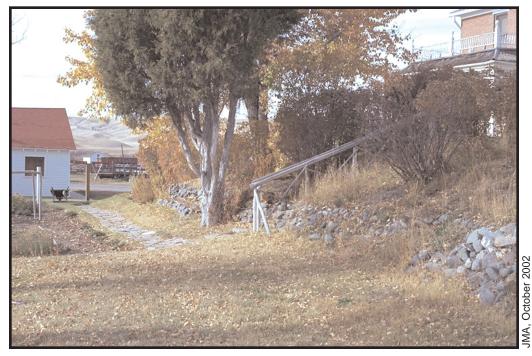
The steep slope between the upper yard and lower garden on the south side of the house contains a large cottonwood tree among a double row of lilac shrubs. Four barberry shrubs (*Berberis thunbergii 'Atropurpurea'*) line the edge of the steps connecting these areas, two on either side. One juniper, two gooseberry shrubs (*Ribes sp.*) and a cotoneaster shrub (*Cotoneaster acutifolius*) are located near the bottom of the terraced garden (see Photo 3-3-5).

Photo 3-3-5 : (AE-24) A large juniper tree, cottonwood tree, and lilac shrubs dominate the slope.

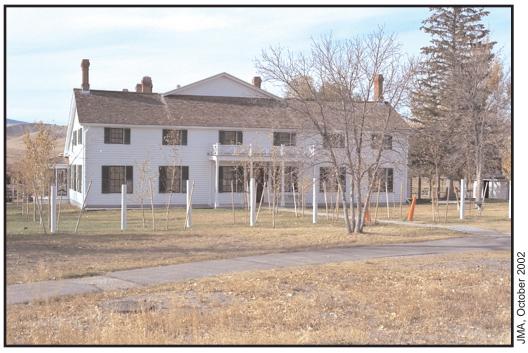
The first pathway visitors encounter as they make their way to the residence is the NPS installed **asphalt sidewalk** leading from the Visitor Center Complex to the ranch. This sidewalk is approximately six feet wide (see Photo 3-3-6).

Photo 3-3-6 : (AE-05) An asphalt sidewalk connects the residence with the Visitor Center.

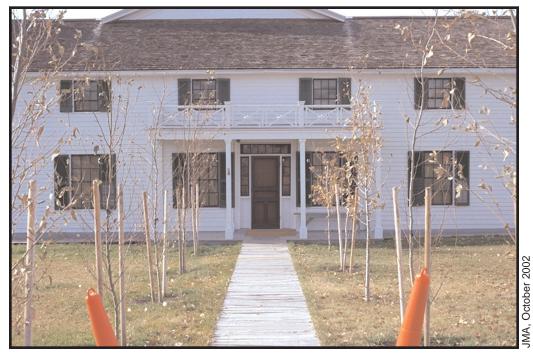
After leaving the asphalt sidewalk, visitors encounter the **wood plank walk** that leads to the front porch of the residence (see Photo 3-3-7). This walk is a NPS reproduction (1986) of a period walk that existed during the Grant-Kohrs era.⁵ The walk consists of three-feet-wide planks set flush with the ground. The walk runs down the center of the front yard, east to west, and then along the length of the building façade. A secondary wood plank walk extends from the northeast corner of the Kohrs addition at the side door, north to the gravel access drive/gate.

Photo 3-3-7: (AE-14) A wood plank walk leads to the front porch of the residence.

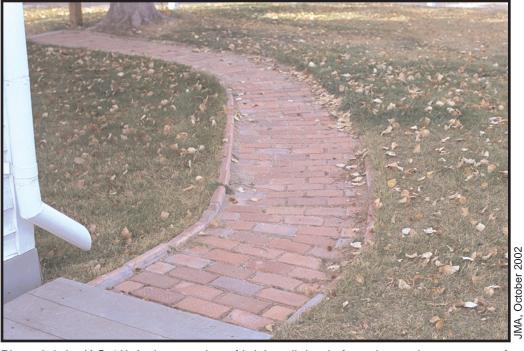
A short section of **brick walk** leads from the northeast corner of the Grant house, abutting the wood plank walk, and then curves westward (see Photo 3-3-8). The brick walk is approximately three feet in width and set in a running bond pattern with brick edging. It ends at a granite stone set at ground level at the gate entrance.

Photo 3-3-8: (AG-12) A short section of brick walk leads from the northeast corner of the Grant house, abutting the wood plank walk, and then curves westward.

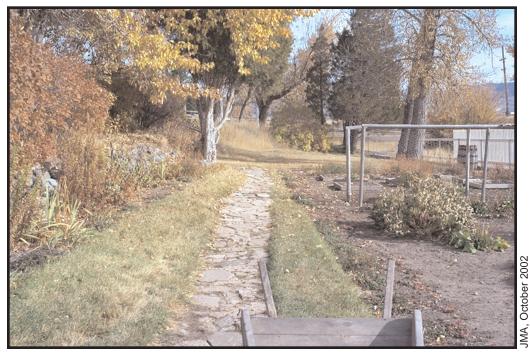
Flagstone walks are located on the south, east, and north sides of the house (see Photo 3-3-9). These walks, built in 1997-98 by the NPS, are between two and three feet in width and are constructed of flagstones set flush with the ground. The southern walk begins at the stone steps located between the lilac bushes on the south side of the house and heads straight west until it

Photo 3-3-9: (AF-05) Flagstone walkway in the lower garden.

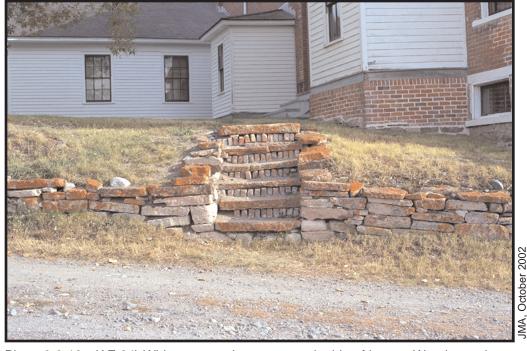
Because the topography of the land east of the residence slopes more steeply, steps and stairs are needed to facilitate movement over the grade. A **wide stone staircase**, originally built by Con Warren in 1934, leads from the flagstone path north of the residence down to the gravel access drive (see Photo 3-3-10). The staircase is part of the retaining wall that curves around this side of the house. It has six thick, rectangular stone treads, each resting on a series of small, cut stone risers. The staircase sits between stacked stone cheek walls.

Photo 3-3-10 : (AF-24) Wide stone staircase on north side of house. Wooden stairs off the kitchen can be seen in the background.

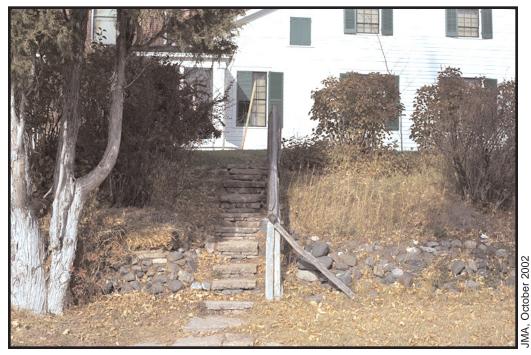
A narrow stone staircase with a wooden handrail is located on the slope north of the garden and south of the house (see Photo 3-3-11). Nine rectangular, cut stone treads rest on rectangular, cut stone, stacked risers. Built in 1934 by Con Warren, this staircase was reconstructed in 1987 by the NPS. The wooden handrail, also reconstructed by the NPS in 1987, consists of three wooden posts supporting a wood railing; thin, wood members form a decorative pattern between the posts.⁹

Photo 3-3-11: (AF-01) A narrow stone staircase with a wooden handrail is located on the slope north of the garden and south of the house.

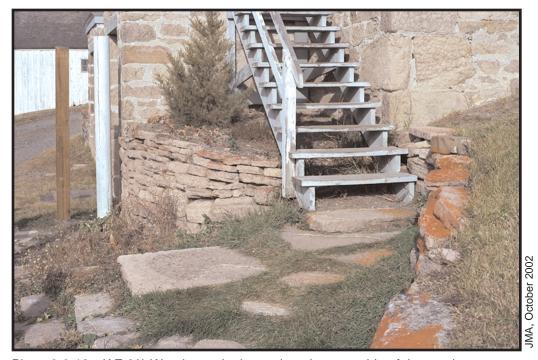
Wooden stairs are located on the west side of the porch (see Photo 3-3-12). The gray-painted steps lead from the porch to the flagstone path below. It consists of wood treads sitting on a wood stringer. A white-painted wood handrail is attached to the west side of the stairs. Other sets of wooden steps can be found on the east side of this porch, as well as along the enclosed porch on the north side of the house.

Photo 3-3-12: (AF-20) Wooden stairs located on the west side of the porch.

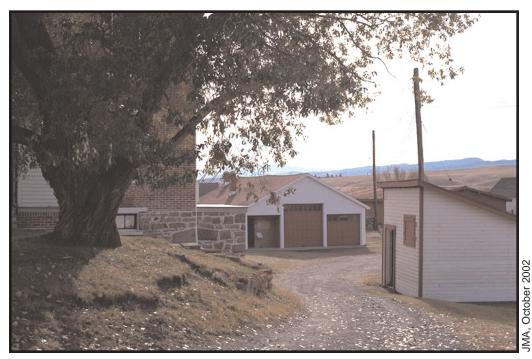
A **gravel access drive** (Bunkhouse Road) wraps around the northern and part of the western edges of the Grant-Kohrs house yard (see Photo 3-3-13). The dark-colored gravel drive is between twelve and fifteen feet in width.

Photo 3-3-13: (AG-08) Bunkhouse Road.

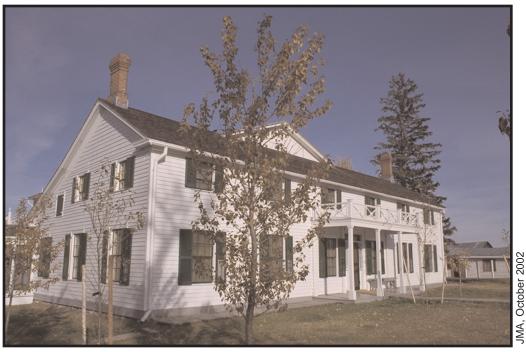
The Main Residence has a T-shaped footprint; the log Grant residence forms the cross of the T (see Photo 3-3-14), while the brick Kohrs addition forms the perpendicular post (see Photo 3-3-15). A conservatory, open porches, and vestibules slightly disrupt this shape. Viewed from the south, north, and east, the 1890 addition has two stories which become three stories on the west elevation by virtue of a full basement. The Kohrs addition has simple structure, massing, and fenestration while the Queen Anne-detailed open porch near the southwest corner is more ornate.

Photo 3-3-14: (COMP-07) The Main Residence has a T-shaped footprint; the white frame Grant residence forms the cross of the T.

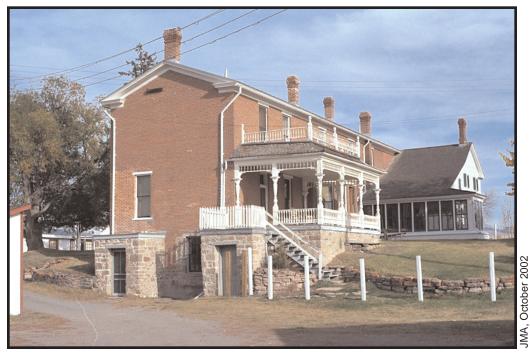
Photo 3-3-15: (AF-19) The 1890 brick Kohrs addition forms the perpendicular post.

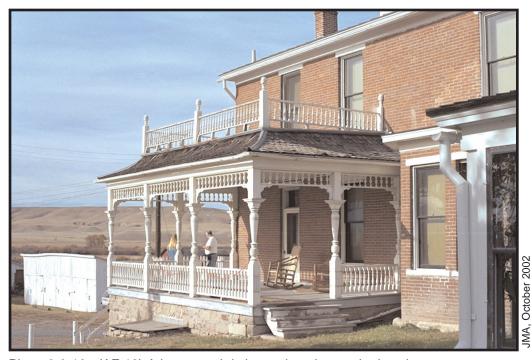
The south elevation of the Kohrs addition features the conservatory, a large bay that defines the dining room, and a substantial open porch, (see Photo 3-3-16). All windows of the Kohrs addition have bull-nosed trim and are paired with painted wood lintels and sills.

Photo 3-3-16: (AF-12) A large porch is located on the south elevation.

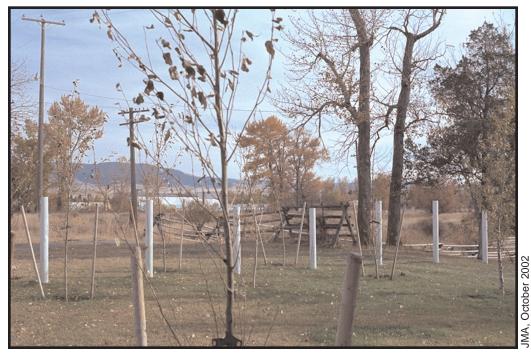
During the time of the site visit, the **white picket fence** surrounding the Kohrs residence was under construction (see Photo 3-3-18). Now complete, this fence encloses the Grant-Kohrs yard.

Photo 3-3-17: (AG-16) White picket fence under construction.

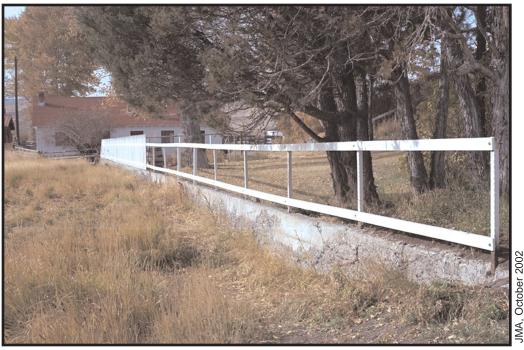
A portion of the **white picket fence**, located along half of the southwestern edge of the residence yard, consists of thin, square, white-painted posts set into a concrete curb and supporting two horizontal rails. White-painted pickets are attached to the horizontal rails. This fence was only partially complete during fieldwork (see Photo 3-3-19). Readers should refer to the CLI (2003) for details concerning the reconstruction of this landscape feature.

Photo 3-3-18: (AE-21) White picket fence along south edge of the lower garden. This fence has been replaced with a period reproduction.

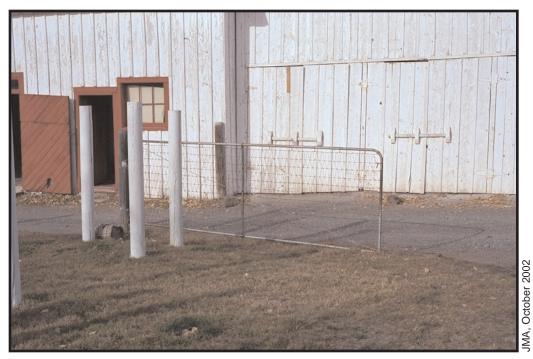
A **Wire Mesh Gate** (see Photo 3-3-20) was located along the gravel access drive between the front yard of the Grant-Kohrs residence and the Bunkhouse. This gate was replaced by a replica

double hung wooden gate in 2003 (photo not available). It is intended to control vehicular and livestock access to the lower portions of the ranch.

Photo 3-3-19: (AG-10) Wire mesh gate. This gate was replaced with a regular double-hung wooden gate in 2003.

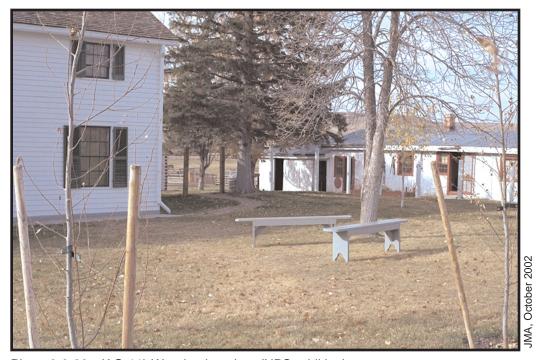
Two gray-painted **wooden benches**, (see Photo 3-3-21) are located on the east side of the residence, near an ash tree in the front yard. These moveable benches were made by the NPS for visitor use, and based upon a historic pattern. They have long, flat, plank seats and short, plank supports attached to a rectangular wooden frame located beneath the seat. The supports of decorative designs cut into their bases.

Photo 3-3-20: (AG-11) Wooden benches (NPS addition).

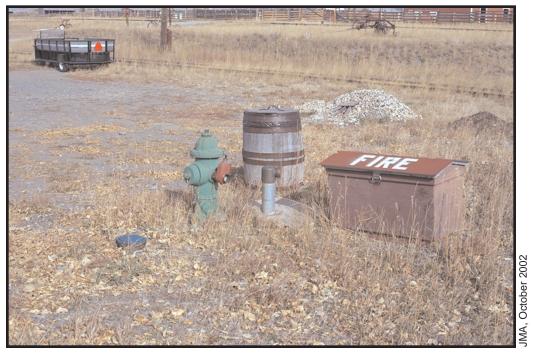
Located east of the residence and near the railroad bed, the **fire box** consists of a small, brown-painted rectangular box with a tiny gable lid. The lid is painted red and has the word "FIRE" stenciled in white paint. Immediately north of and adjacent to the fire box are a **green fire hydrant**, **stanchion pipe**, and **utility cover** (see Photo 3-3-21). The fire hydrant is of contemporary style and code and is painted green. The stanchion pipe is a round, metal, capped pipe rising several inches above grade and set into a concrete footing. The utility cover is a round, metal, blue-painted cap rising only one or two inches above grade. These features were added by the NPS.

Photo 3-3-21 : (AE-08) Fire hydrant, fire box, pipe, utility cover, and trash barrel (NPS additions).

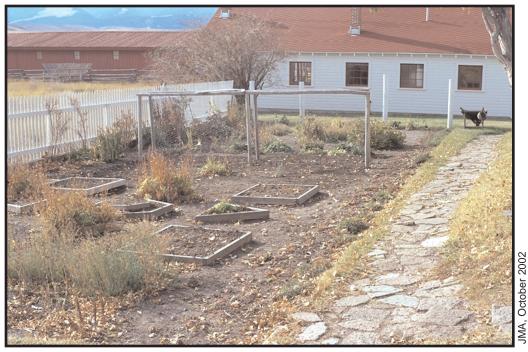
Within the garden plot, **wooden raised-bed frames** help to separate plant types and also act as a design element (see Photo 3-3-22). Low, wooden, milled boards, most likely 2 inches by 4 inches in dimension, form various geometrically-shape raised beds in the eastern half of the garden. Two **wooden trellises** are located in the middle of the garden. These are used to support sweet pea vines. Each trellis consists of three vertical poles supporting an overhead crossbar. Wire mesh stretches across the trellis frame.

Photo 3-3-22 : (AF-03) Wooden raised bed frames and sweet pea trellises in the lower garden.

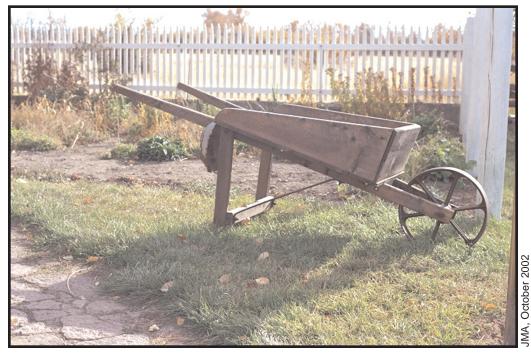
A historic reproduction wood and metal **wheelbarrow** is displayed near the northwest corner of the garden plot, (see Photo 3-3-23).

Photo 3-3-23: (AF-04) NPS replica wheelbarrow.

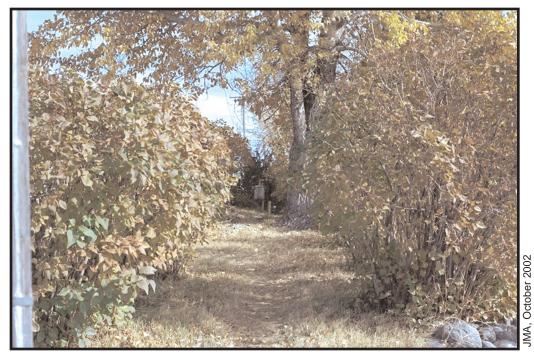
Utility features, in the form of **capped pipes** exist near the southeast corner of the house. These pipes rise only a few inches above ground-level. **Utility meters** and a yellow **stand-pipe** are located on the western side of the residence, between the rows of lilac shrubs (see Photo 3-3-25).

Photo 3-3-24 : (AF-07) Utility meters and a yellow stand-pipe are located on the western side of the residence, between the rows of lilac shrubs.

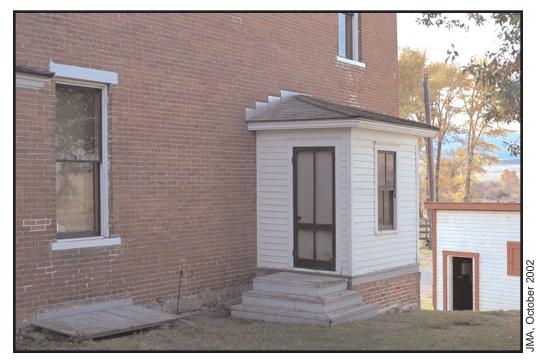
Photo 3-3-25: (AG-04) Wood cellar covers.
